NASA TN D-7616

# ENDURANCE TESTING OF DOWNSTREAM CATHODES ON A LOW-POWER MPD THRUSTER

by *James A. Burkhart and James R. Rose*

*Lewis Research Center  
Cleveland, Ohio 44135*

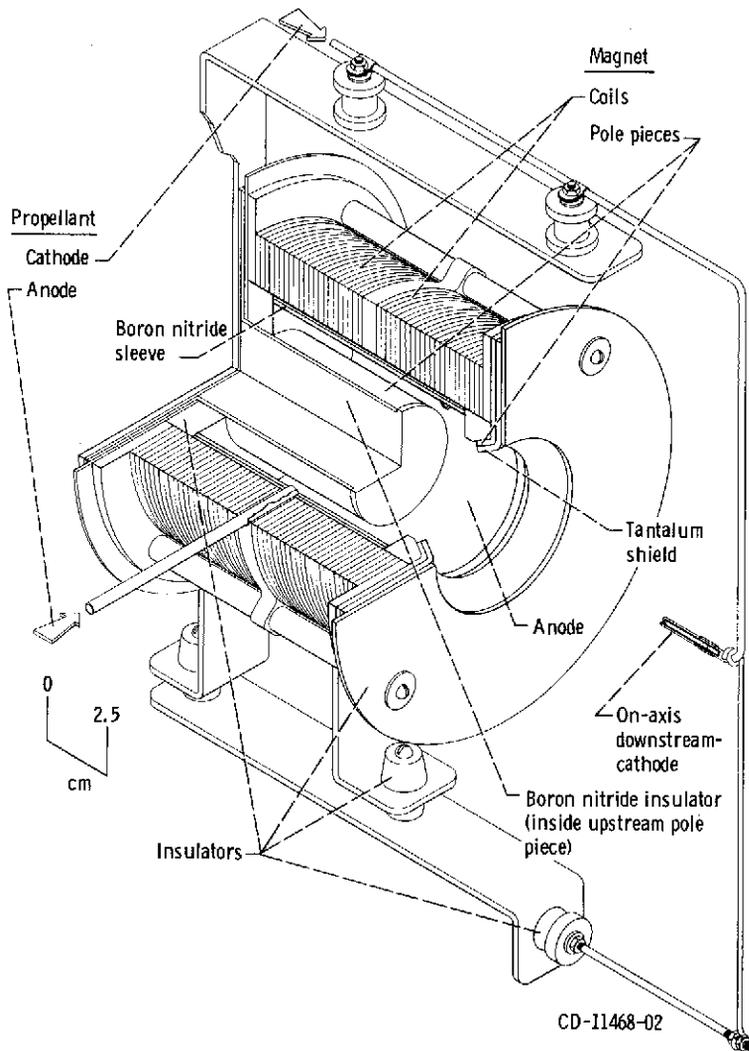
Figure 1. - Baseline MPD thruster. Cathode shown, on-axis downstream cathode (design 1).

Figure 1 shows what shall be called throughout this report the baseline MPD thruster. This baseline MPD thruster is identical in design and fabrication to the one tested in reference 2 with four exceptions: (1) the hollow cylinder part of the upstream pole piece is filled entirely with boron nitride, (2) a boron nitride cylindrical sleeve is used between the anode and edge wound magnets to insulate them, (3) the cylindrical anode has a single cut (about 0.5 cm wide) along its entire length parallel to the thruster axis, and (4) a tantalum shield (flame sprayed on all surfaces with alumina 0.05 cm thick) was used to protect the inside surface of the frustum-shaped part of the exhaust end pole piece from severe ion bombardment.

(1) On-axis downstream cathode (design 1). This is shown as a part of figure 1 and in greater detail in figure 2. It consists of a hollow 2-percent thoriaated tungsten cathode located on the thruster centerline. A very small amount of xenon propellant flow from the cathode was used to maintain the discharge. This flow is out of the cathode tip (orifice plate) in a direction upstream relative to the thruster body.

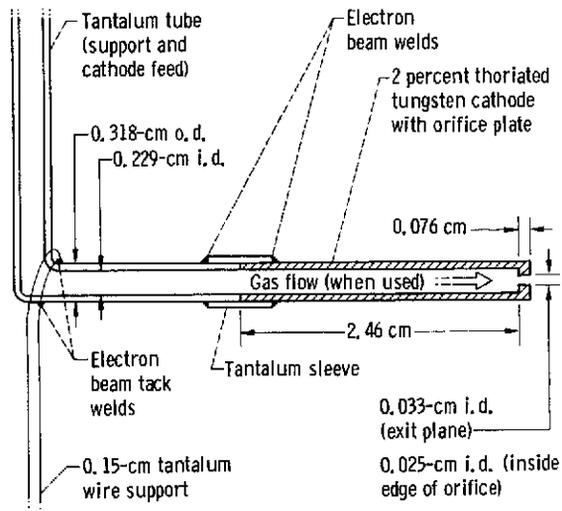
Figure 2. - Cross-sectional schematic of on-axis downstream cathode (design 1).

The on-axis downstream cathode (design 1) of figure 2 was operated under conditions (0.9 mg/sec xenon flow, 230 V anode to cathode, 2.2 A of discharge current and 0.023 T average magnetic field on centerline of discharge chamber) quite similar to the best data obtained in reference 2, namely, the 24-percent efficient point at an  $I_{sp}$  of 1620 seconds. Figure 10 shows the results after 47.9 hours of operation. The orifice plate is almost completely sputtered away as the sectioned part of the cathode shows. Visual inspection of the cathode tip as seen through the optics of a pyrometer indicated that the orifice plate hole had already opened to a large diameter after 40 hours of running. Cathode flow demand also increased steadily during the period of operation, indicating that the orifice plate hole was opening and that the desired current level could only be maintained by increasing flow. The severed propellant feed tube condition (readily apparent in fig. 10) began developing at the 39-hour mark.

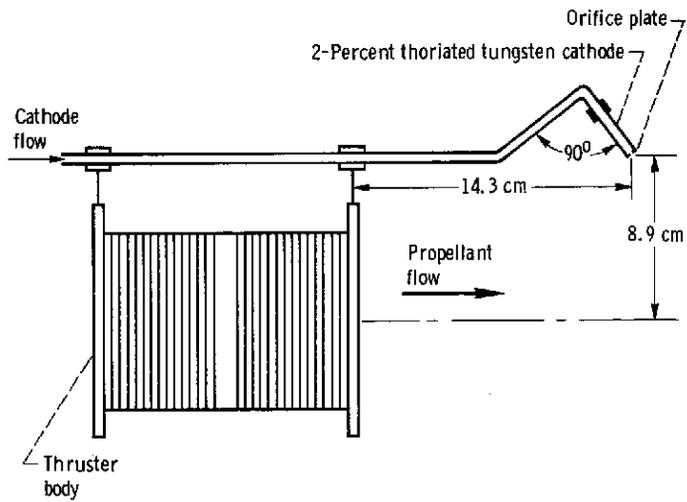
Figure 3. - Baseline MPD thruster with original off-axis downstream cathode (design 2).

(2) Original off-axis downstream cathode (design 2). This cathode (fig. 3) is off the thruster axis with the tip pointing downstream. The propellant emerging from the orifice plate in the cathode tip is directed downstream at an angle of  $45^{\circ}$  relative to the thruster axis. The structure and geometry of the thoriaated tungsten hollow cathode is identical to that shown in figure 2 and is mated to the tantalum feed tube by the same tantalum-sleeve electron-beam-weld technique illustrated in figure 2.

The rapid rate of failure of the on-axis downstream cathodes indicated that a drastic change of cathode design and/or location was needed. The original off-axis downstream-cathode thruster (fig. 3) was selected for subsequent testing. The cathode tip position shown was selected for a number of reasons. First, the feed-tube dissections mentioned previously for design 1 showed that little ion sputtering occurred at a radius of 8.9 centimeters. Second, the ion flux density measurements made in reference 4 indicate that the ion flux density at this 8.9-centimeter radius is approximately 35 percent of that on the thruster axis; this low ion flux reduces the number of ions impinging the cathode structure. Third, even with this reduced ion flux, a magnetic field map shows that field lines having a near-to-the-centerline position in the discharge chamber do indeed cross the hollow cathode tip region. This permits sufficient plasma diffusion from the discharge chamber along these particular field lines to heat the cathode tip.

To further improve the possibility of cathode orifice plate survival, the angled downstream pointing of the cathode tip (shown in fig. 3) was employed.

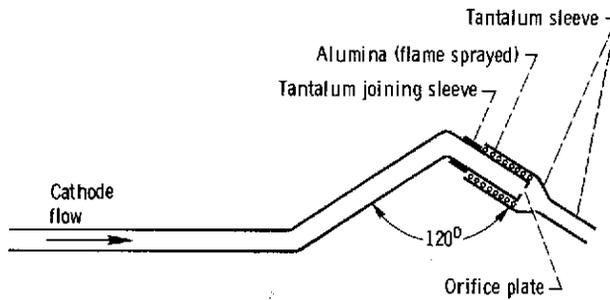
Figure 4. - Cross-sectional view of off-axis downstream cathode with sleeve (design 3).

(3) Off-axis downstream cathode with sleeve (design 3). Figure 4 shows a modified version of the off-axis downstream cathode in which a tantalum sleeve is placed about the thoriaated tungsten cathode. This sleeve was operated electrically common with the cathode and also insulated from it. A 0.035-centimeter-thick layer of alumina on the outside diameter of the cathode provided the insulation.

the only viable alternative, and this could be accomplished by adding the tantalum sleeve shown in figure 4. This sleeve holds neutral density high by inhibiting the radial diffusion of hollow-cathode propellant until it is many centimeters downstream of the cathode tip. To inhibit sidewall cathode deterioration, a molybdenum cathode-protecting rod (similar to that in fig. 6) was used to block out line-of-sight ions emerging from the thruster exhaust port.

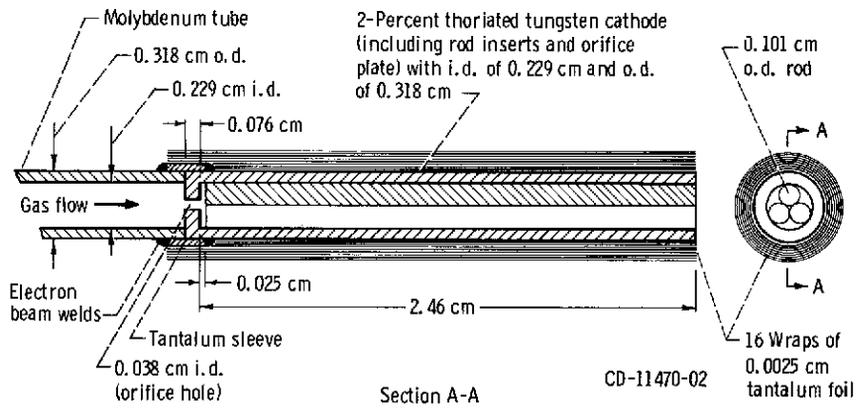
Figure 5. - Cross-sectional view of new off-axis downstream cathode with rods (design 4).

(4) New off-axis downstream cathode with rods (design 4). In this new hollow cathode design (fig. 5) the orifice plate is moved 2.46 centimeters upstream. This cathode uses the concept of wedging 2-percent thoriated tungsten rods into the hollow sleeve part of the cathode structure to protect the cathode orifice plate from direct ion impingement and to permit the cathode to operate at low currents. Three rods (0.101 cm o. d.) are wedged into the hollow such that an 0.025-centimeter gap exists between the ends of the rods and the orifice plate. Xenon propellant is delivered to the cathode structure by a molybdenum tube which has been electron beam welded to the cathode by means of a tantalum sleeve. The 0.038-centimeter-inside-diameter hole in the cathode orifice plate controls the flow rate. Flow exits the cathode through the many voids between rod sets and between the rods and the tube wall. A heat shield consisting of 16 layers of 0.0025-centimeter-thick tantalum foil covers the thoriated tungsten cathode. A 1.27-centimeter-outside-diameter molybdenum protecting bar (fig. 6) is mounted from the exhaust end flange of the thruster to shield the back of the cathode structure from direct impingement of exhaust beam ions. Only the cathode discharge tip is exposed to the beam. (The tip position was selected to be on a magnetic field line which has a near-to-the-centerline position when in the discharge chamber.) Physically, the cathode tip is on the centerline of the molybdenum bar, 1.27-centimeters downstream of the end of the bar. The tip points partially downstream, making an angle of  $53^{\circ}$  with the thruster axis.

The new off-axis downstream cathode (fig. 5) evolved in an effort to solve the instability problems of the design 3 cathode while at the same time consolidating the desirable features of the design 3 cathode into a straightforward design. The sleeve of the design 3 cathode could be electrically common with the orifice plate, and so in the design 4 cathode the sleeve and orifice plate were machined from the same piece of thoriated tungsten. To solve the instability problem, a way had to be found to increase the density in the sleeve portion of the cathode without raising the hollow cathode flow. The three thoriated tungsten rod inserts are the means of achieving this. Tantalum heat shielding of the cathode was also added in an attempt to lower cathode loss, thus cutting the amount of ion bombardment of the cathode required to maintain the discharge current.

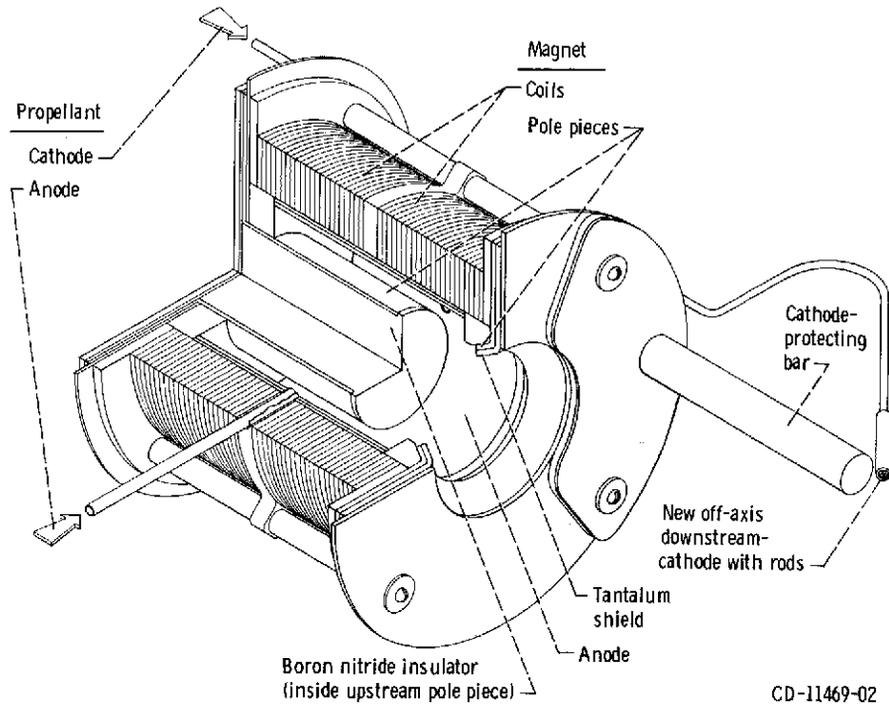
Figure 6. - Baseline MPD thruster incorporating new off-axis downstream cathode with rods (design 4). Thruster life-tested for 1332 hours.

The thruster configuration of figure 6 was placed on endurance test in the new super-bell-jar facility. The circuitry shown in figure 9 was used. Discharge voltage (anode to cathode) was maintained at 250 volts and discharge current (passing in series through the magnets) at 2.3 amperes. Anode propellant flow was maintained at 0.8 milligram per second. Cathode propellant flow varied from less than 0.05 milligram per second to 0.3 milligram per second in response to the current controller holding the current at 2.3 amperes.

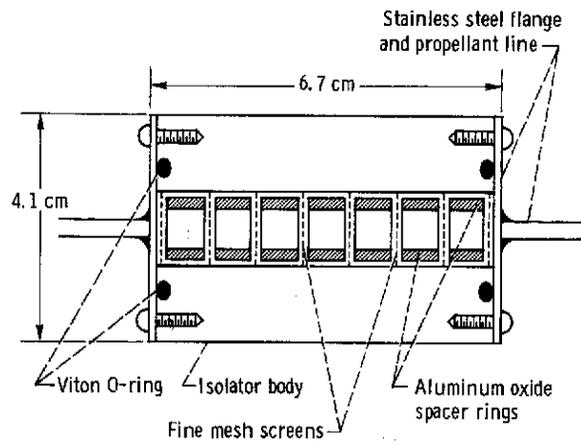
Figure 7. - Isolator cross section. Original isolators employed polycarbonate plastic bodies and final design isolators employed boron nitride bodies.

For the entire sequence of tests, the majority of propellant feed-line lengths, the solenoid valves, and the calibrated leaks were at ground potential. Isolators (shown in fig. 7) were inserted in both the anode and cathode propellant lines to isolate the anode and cathode from ground potential. All wiring connections and those segments of the propellant lines that operate at either anode or cathode potential were insulated thoroughly with an application of high voltage, high temperature polyimide tape and/or polyimide paint.

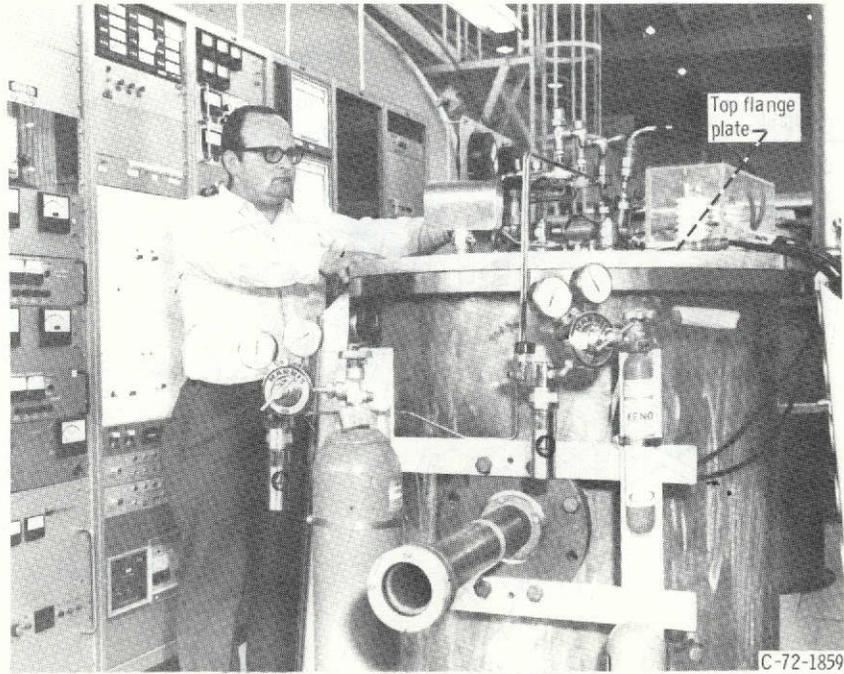
Figure 8. - Super-bell-jar facility.

The second vacuum facility used in testing was the new super-bell-jar facility of the NASA Lewis Research Center (fig. 8). This facility consists of two separate stainless steel bell jars, but only one was used for the testing described. Each bell jar has a 0.86-meter diameter and is 1.7 meters high; each is mounted on top and concentric with a single 0.9-meter diameter oil diffusion pump. Background pressure was maintained between  $8 \times 10^{-3}$  and  $1.3 \times 10^{-2}$  newton per square meter ( $6 \times 10^{-5}$  and  $10^{-4}$  torr). The thruster is mounted from the top flange plate (shown in fig. 8) with the exhaust plume pointing downward along the bell jar axis. Two viewing windows are mounted at different locations on the bell jar circumference for viewing cathode behavior and for taking cathode temperatures by means of a pyrometer.

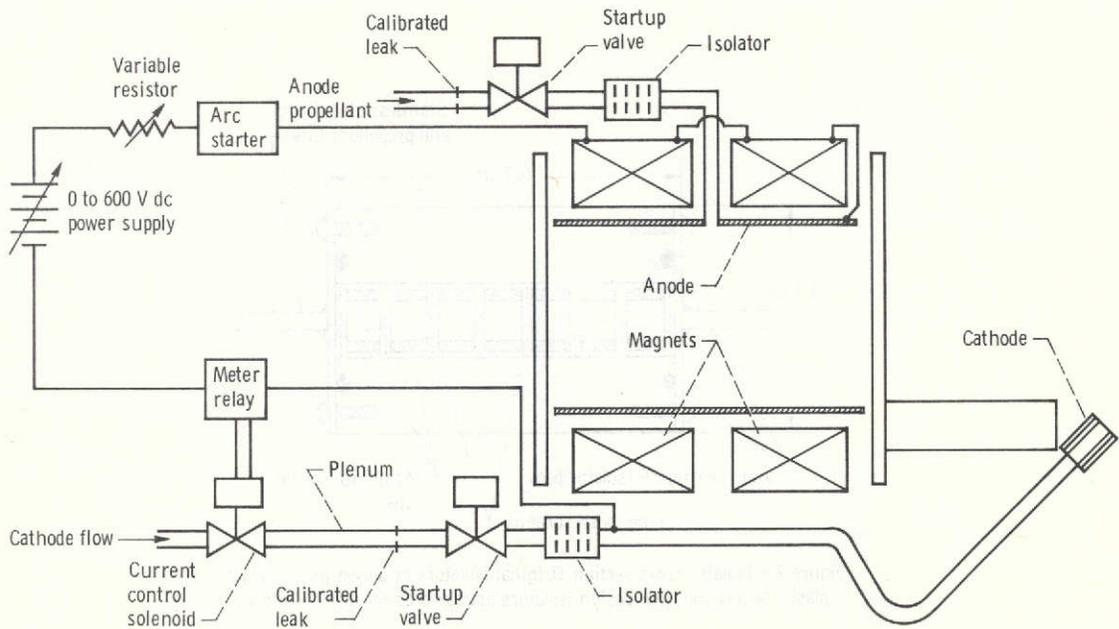
Figure 9. - Thruster circuitry including automatic on-off cathode (discharge) current control.

The thruster discharge is initiated by establishing Paschen law breakdown conditions using an arc starter (fig. 9). Then, the discharge power supply, the cathode current controller, and the flow rates are adjusted to the experimental conditions desired. The anode propellant flow rate is set by varying the pressure upstream of the fixed size anode calibrated leak. Cathode propellant flow is varied by the cathode current controller (fig. 9), which consists of a meter relay and a solenoid valve upstream of the cathode flow calibrated leak. (This cathode current controller is very crude compared to the state of the art in controls. It is of the on-off type and is characterized by overshoots (for a few seconds) upwards of 20 percent of desired value. A compact, simple, and much higher performance (good regulation, little overshoot) servo-control loop can be built.) As the cathode current drops below the preset (desired) value of the meter relay, the solenoid valve is activated and propellant fills the plenum (consisting of the line void between the valve and calibrated leak). The valve recloses as soon as the current goes above the desired value and remains closed (usually many minutes) until the current subsequently drops below the desired value. The flow rate can be computed from the duty cycle of the valve, the calibration curve of the calibrated leak, and the pressure upstream of the leak.

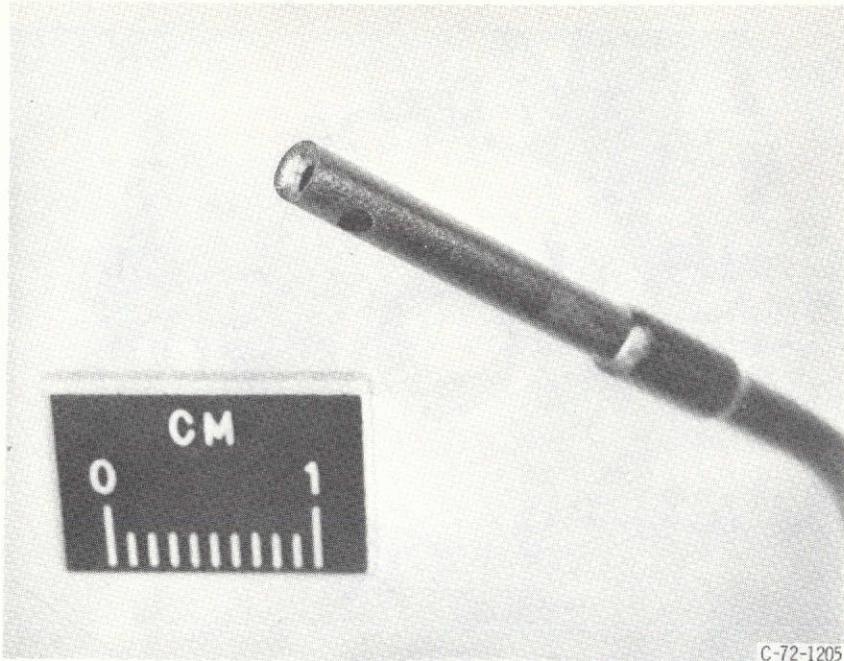
Figure 11 shows the condition of this off-axis cathode tip after 80.8 hours of operation. The orifice hole is again enlarged (0.307 cm i. d. after test compared to 0.033 cm i. d. before), and a hole has been sputtered into the side wall of the cathode. This hole was located on a line-of-sight path relative to the thruster exhaust port. Also, the inside of the frustum-shaped part of the exhaust pole piece was sputtered clean of alumina; this condition necessitated the use of the tantalum pole piece shield mentioned previously. A second test which was made with this geometry and the added tantalum pole piece shield endured for 160 hours before a hole (slightly larger this time) appeared in the cathode side wall. The cathode orifice plate showed little wear. Visual data within the first few hours of operation indicated that a small crack existed in the sidewall at the location of the final failure mechanism hole. It can therefore be postulated that the cathode emitted at the cracked sidewall surface instead of at the normal orifice plate hole for most of the 160 hours of operation. Hence, the total sputtering phenomena took place at or in the vicinity of this crack.

Figure 11. - Condition of original off-axis downstream cathode (design 2) after 80.8 hours of operation.

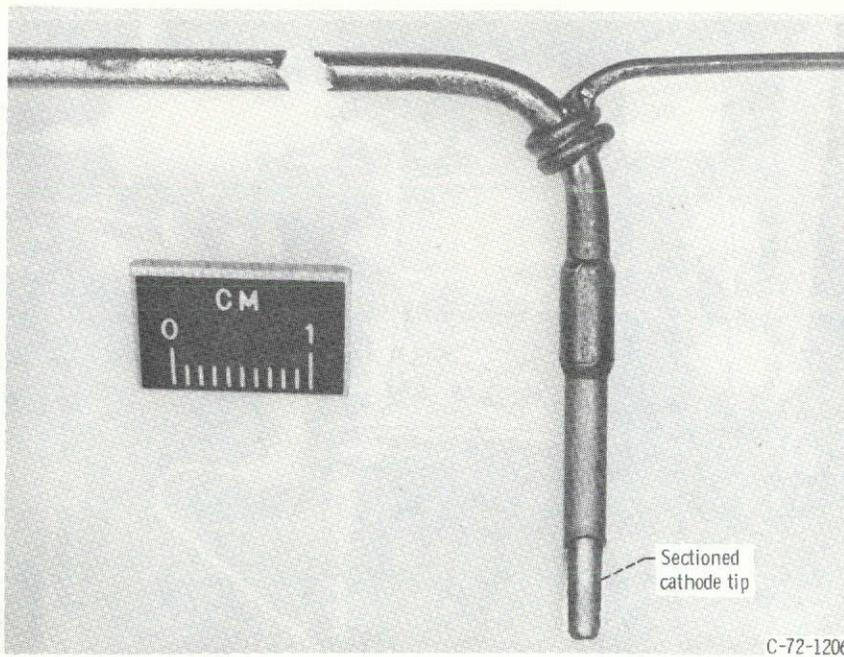
Figure 10. - Condition of on-axis downstream cathode (design 1) after 47.9 hours of operation. Cathode tip has been sectioned.

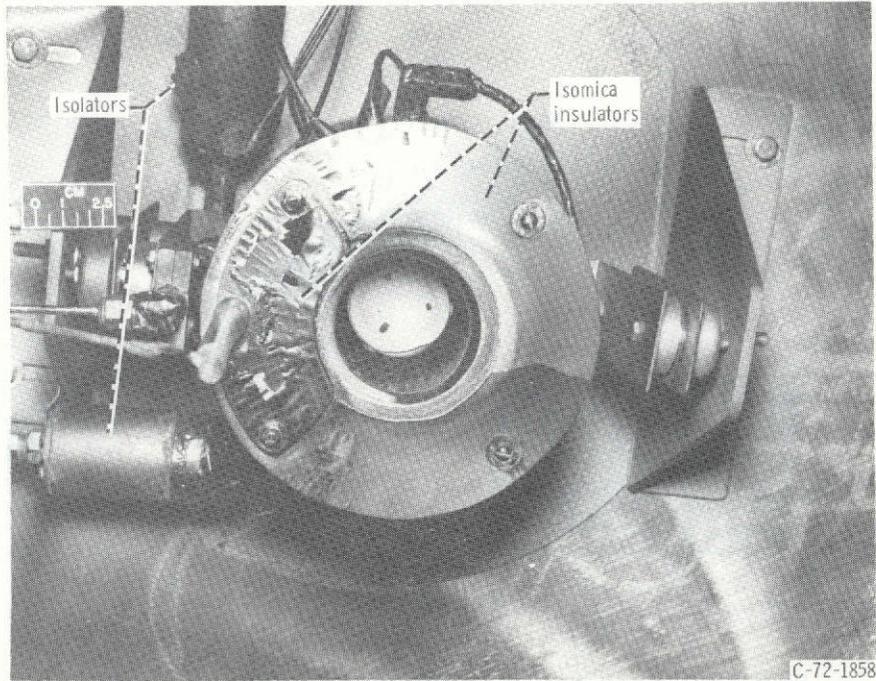
After 735 hours of operation, the bell jar was opened for the first time since the start of testing. Figure 12 shows the condition of the thruster at the 735-hour mark. The two polycarbonate-plastic isolators were damaged and were leaking through the surface of the cylindrical body. The greatest leakage was on the cathode isolator, thus explaining the excessive cathode propellant demand prior to bell jar opening. Apparently the ambient temperature was high enough to melt the polycarbonate plastic, and this caused leakage with subsequent arcing. To remedy this, a new set of isolators with boron nitride bodies was used for the remainder of the test. These isolators were also placed out at a larger radius, 15 to 25 centimeters from the thruster axis. No subsequent problem was observed.

Figure 12 also reveals that severe sputtering of the boron nitride insulator, which fills the cylinder of the upstream pole piece, has occurred. The center part of the insulator is recessed, and a small part of the tip of the insulator which shielded the pole piece has been eroded away. The three holes,  $120^\circ$  apart, which appear black on the photograph need some explanation. At the start of testing the boron nitride insulator was held in place by three screws which were placed through the pole piece cylinder surface and radially into the boron nitride. The black spots are those places where the side walls of the screw holes have been eroded away. A careful inspection of fig. 12 reveals the screw heads at the surface of the pole piece cylinder. These screws were moved to the extreme rear part of the cylinder when testing was resumed after the 735-hour inspection.

Figure 12. - Life-test thruster after 735 hours of operation.

The boron nitride insulator shown in figures 12, 18, and 19 sputters far too much to be of use for real missions. Again research into the processes present in the new modified downstream-cathode thruster of figure 20 may aid the endurance problem for the area of future research in that device will probably be at the downstream edge of the upstream pole piece. The data gathered during the tests of reference 3 indicated that an important process occurs within the 0.318-centimeter axial distance downstream of the upstream pole piece, although the process and/or processes were not identified.

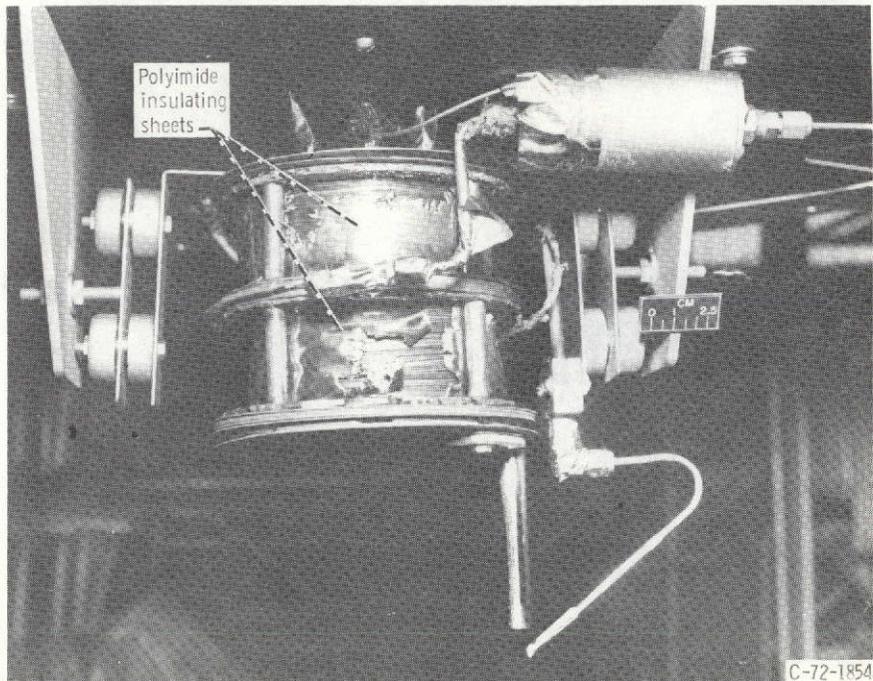
Figures 13 and 14 afford a comparison of thruster damage and erosion at 735 hours and at the final 1332 hours. The molybdenum cathode-protecting bar has been sputtered on a line-of-sight from the plasma exhaust. Exact dimensions are given in the sketches of figure 15. The rate of erosion appears approximately linear with time ( $3.86 \times 10^{-4}$  cm/hr based on 735-hr data for minimum cross section and  $4.01 \times 10^{-4}$  cm/hr based on 1332-hr data). Hence, the total life of the 1.27-centimeter-diameter molybdenum bar can be projected to be approximately 3000 hours. One large disadvantage of this technique for protecting the cathode is that the sputtered bar material is a potential plating substance for spacecraft surfaces.

The pattern of cathode erosion is shown in the photographs of figures 13 and 14 and is sketched in figure 16. Tip erosion is not uniform across the cathode diameter. The photographs indicate that the tip erodes in such a fashion that the plane of the new eroded tip surface is parallel to the thruster axis. This is most apparent in figure 14 if one ignores the small piece of protruding material at the very bottom of the cathode. The rate of cathode erosion calculated from the most foreshortened side of the cathode is  $2.18 \times 10^{-4}$  centimeter per hour based on 735 hours of operation, but it is  $4.77 \times 10^{-4}$  centimeter per hour based on 1332 hours of operation. (Some of this discrepancy may be due to the period of approximately 200 hr, just before the 735-hr shutdown and inspection during which the cathode isolator was leaking and the cathode tip flow was uncertain.)

Figure 13. - Side view of life-test thruster after 735 hours of operation.

The data of the 1332-hour life-test point to areas where additional research is needed. The exact location of the cathode needs further study. A look at figures 13, 14, or 15 shows that the molybdenum cathode-protecting bar has very little wear at a position close to (1 to 2 cm) the exhaust end pole piece of the thruster. Perhaps the cathode should be off-axis but positioned a centimeter or two downstream of the exhaust pole piece. This would also eliminate the need for a protecting bar and its associated metallic sputter, a potential spacecraft contaminant.

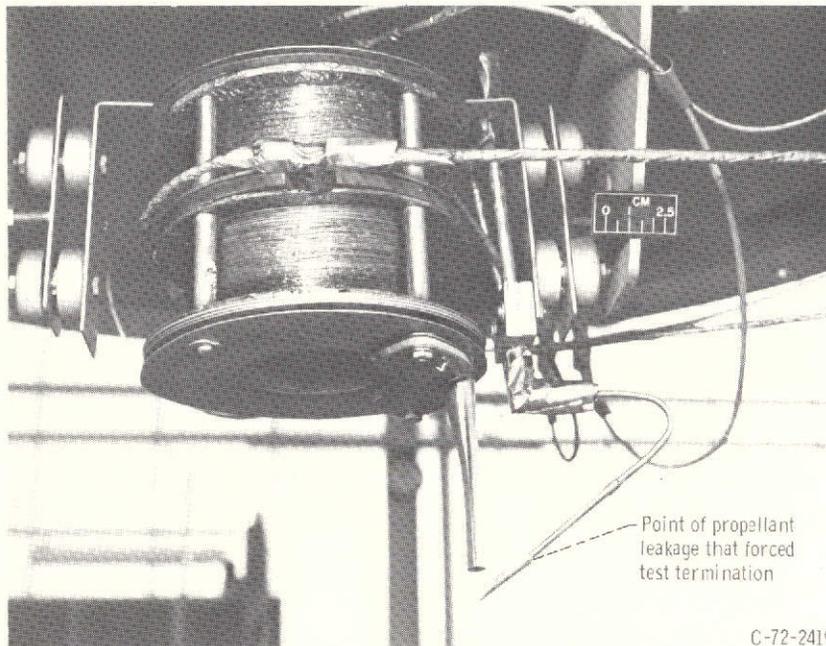
C-72-2419

A total operating lifetime of 1332 hours was achieved. The test was terminated because of severe leakage in the cathode feedline at the point shown in figure 14. At this point the tantalum sleeve (used to join the cathode to the feedline) is electron beam welded to the molybdenum line. The point of leakage was very embrittled, and the entire cathode broke loose from the feedline at this embrittled surface when the thruster was removed from the bell jar. The technique of joining the thoriated tungsten tip to the feedline using the refractory metal sleeve appears sound. However, a better choice of refractory metals should be used in the future. Using a tantalum sleeve to join tungsten to molybdenum (as done for this test) is a poor technique since the coefficient of thermal expansion of tantalum is much different from that of tungsten and molybdenum. It can be postulated that the ultimate failure of this endurance test at 1332 hours was probably due to this mismatch in the coefficient of thermal expansion causing severe stresses in the refractory metals under hot operation with subsequent embrittlement and cracking.

Figure 14. - Side view of life-test thruster after 1332 hours of operation.

The cathode tip wear shown in figure 14 indicates that the tip sputters in such a way as to have the plane of the tip parallel to the thruster axis. This hints that the cathode might well be placed on a radial line relative to the thruster axis with no downstream pointing at all.

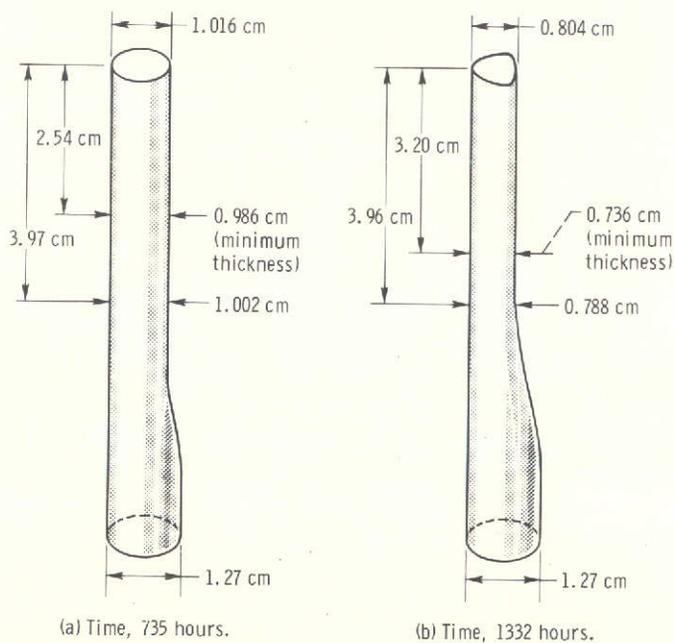
Figure 15. - Comparison of molybdenum cathode-protecting bar dimensions at two different times.

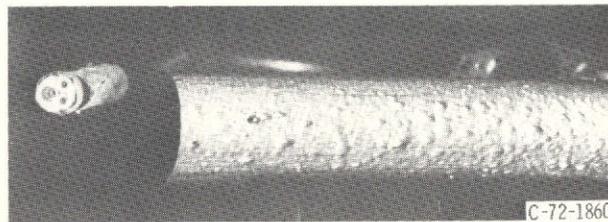
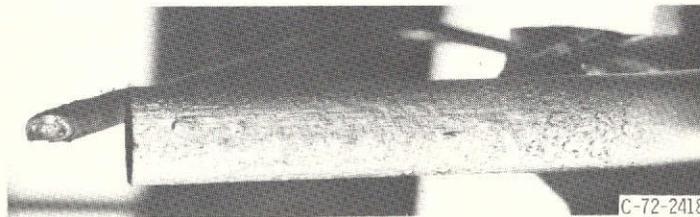
The photographs of figure 17 show the cathode tip contour, in particular the hole pattern. After 735 hours, the hole at the greatest distance from the thruster body (extreme left in photograph) was the most enlarged of the three between the thoriated tungsten rod inserts and the cathode tube wall. In general, the plasma glow for the first 735 hours appeared at this hole, although there was some jumping to other holes. Yet after 1332 hours this hole is almost closed, with one of the other two holes exhibiting the largest diameter. The shift in plasma glow followed this change in hole size with the glow usually coming from the largest diameter hole. The cathode was sectioned near the orifice plate (much like what was done in fig. 10). This revealed that the hole patterns only penetrated a few tenths of a centimeter, and that beyond this the original rod geometries and the orifice plate dimensions appeared unchanged.

(a) Time, 735 hours.

(b) Time, 1332 hours.

Figure 17. - Cathode and molybdenum cathode-protecting bar at the two life-test times indicated.

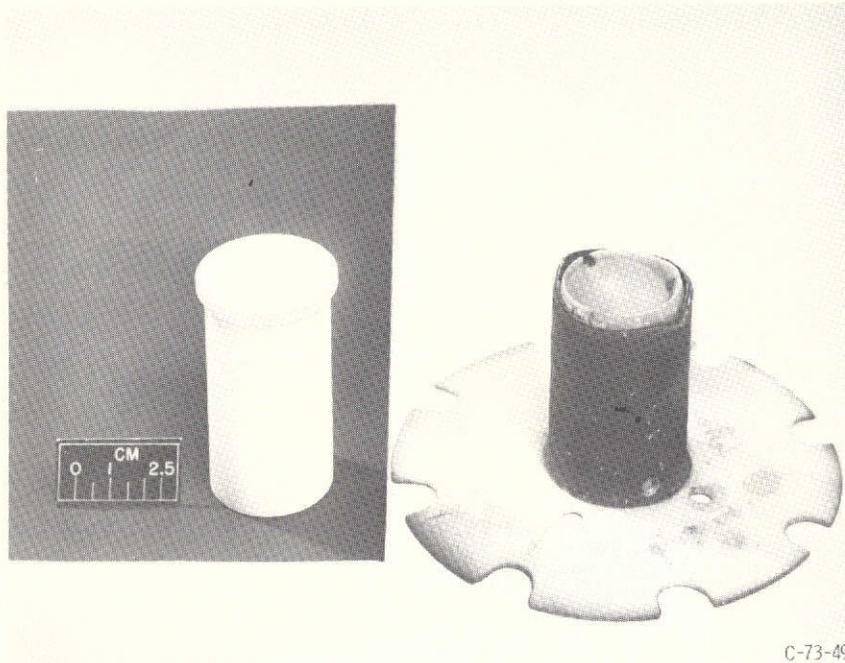
C-73-498

Figure 18 shows this same insulator before testing and the condition of the insulator and upstream pole piece at the completion of testing. After 1332 hours the upstream pole piece cylinder is showing some erosion as well as the boron nitride.

Figure 18. - Boron nitride insulator before life-testing was started, and boron nitride insulator and upstream pole piece after 1332 hours of testing.

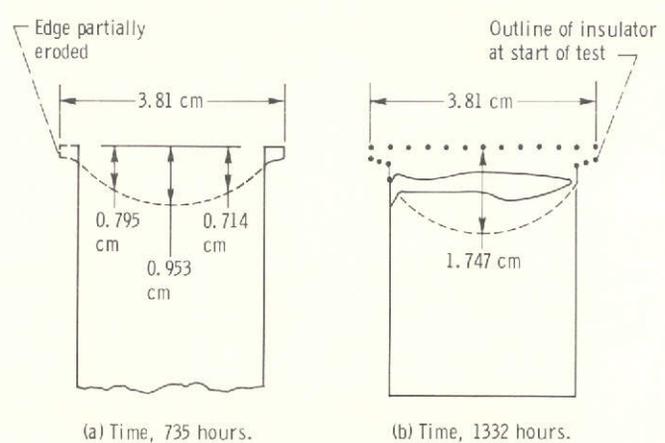
Figure 19 compares the wear on the boron nitride insulator at approximately the midpoint and at the end of the 1332-hour life test. It can be seen from the dimensional changes that backplate sputtering is approximately linear with time.

Figure 19. - Cross-sectional sketch of boron nitride insulator used inside upstream pole piece. Sputtering wear shown for two different life-test times.

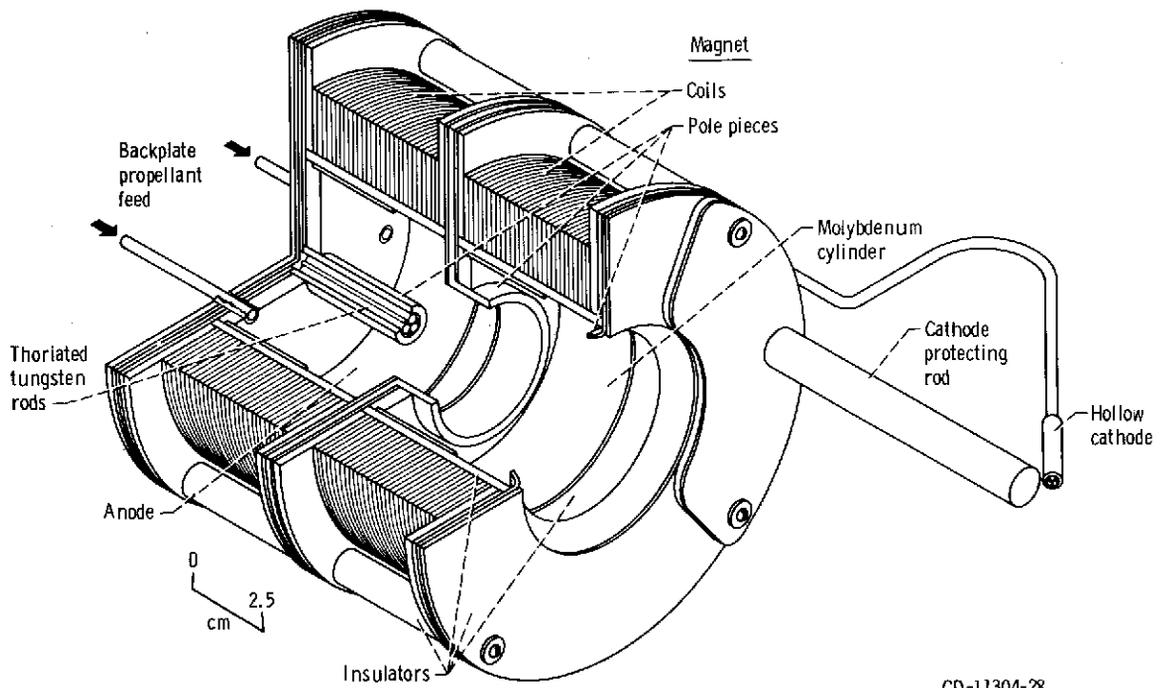
Data gathered on a modified downstream-cathode MPD thruster (ref. 3) (fig. 20) is also encouraging when examining potential cathode positions. As can be seen from figure 20, this thruster has a new magnetic field pole piece arrangement but uses the cathode protecting bar and the new off-axis downstream-cathode design. This thruster evolved from a separate set of experiments in another facility which were conducted at approximately the midpoint of the 1332-hour life test. Because of the time needed to complete the life test, the performance data on this modified thruster appeared in the literature first. It is felt that this new and modified MPD thruster represents the latest in the "state-of-the-art". It should be also pointed out that the modified thruster cathode was packed more tightly, having nine 0.0125-centimeter-diameter rods inserted into the sleeve in addition to the three 0.101-centimeter-diameter rods. In contrast to the diffuse plume of the 1332-hour life-test thruster, the visible light in the exhaust of this high-performance modified thruster is very well collimated into a solid cylinder with an outside diameter the size of the hole in the exhaust pole piece. Perhaps sputtering of the cathode and/or cathode-protecting bar could be minimized by simply keeping these objects out of, or at the edge of, the collimated part of the exhaust plume.

Figure 20. - Modified downstream-cathode MPD thruster using a new off-axis downstream cathode with rods.  
 (See ref. 3 for performance data.)

In general, low-power MPD thruster performance improvements have always been accompanied by lowering the discharge current. For example, the high-performance thruster shown in figure 20 has a lower characteristic discharge current when compared to the thruster used for the 1332-hour life test. Lowering the discharge current potentially improves the cathode life, because less ion bombardment of the cathode tip is required. In general, and verified experimentally, the new off-axis downstream cathode with rods can operate in a stable discharge mode at lower and lower currents as the sleeve is more tightly packed with rods. Hence, additional cathode life and larger rod packing fractions appear interrelated.
